Toughened and Heat Strengthened glass Associated distortions and visual effects

Purpose of this document.

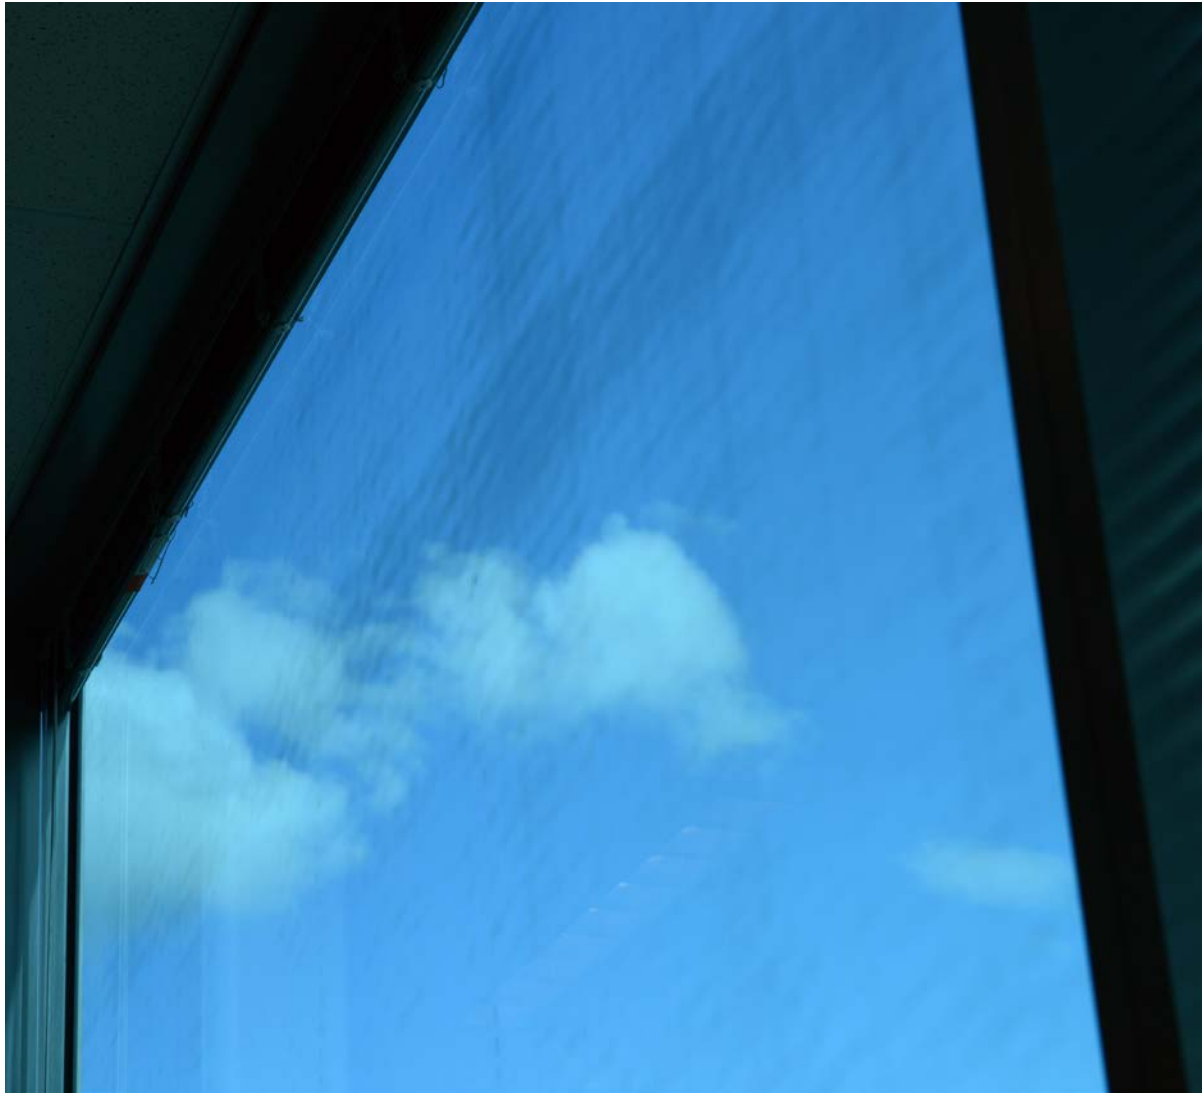
The darker areas in this photo show a leopard spot pattern and a bar pattern. This pattern was visible under natural light late in the day. The photo is taken at an acute angle because it accentuates the visibility of the pattern. The pattern would be far less obvious if the photo was taken from a position perpendicular to the glass.

These visual effects have some common names such as "leopard spots". In the industry it is commonly known as the "quench pattern" or "toughening pattern". A more scientific description is "Photoelasticity". It can appear as a soft grid of lines or spots of alternating lighter and darker areas. In addition some furnaces will also produce a pattern of soft rectangular bars in addition to the grid pattern. "Leopard" spots can be commonly seen in the toughened rear window of motor cars in the early morning or late evening.
